**Document Control No. 4400-59-AEVU**

**FIVE-YEAR REVIEW  
FINAL REPORT**

**PERDIDO GROUNDWATER CONTAMINATION SITE  
PERDIDO, BALDWIN COUNTY, ALABAMA**

**MAY 1995**

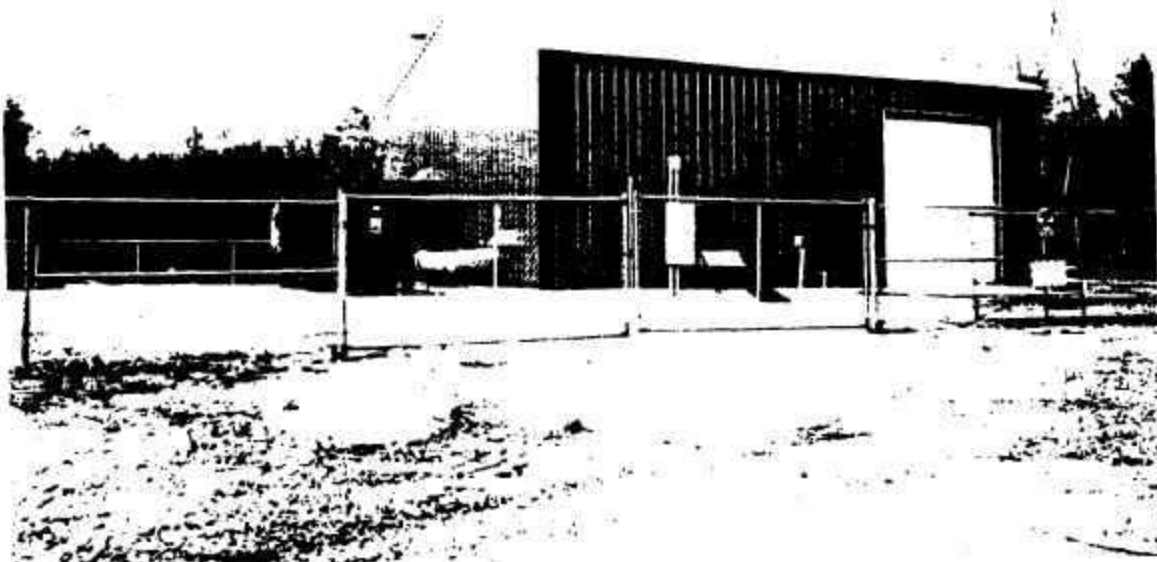
**Photograph No. 1**

**Description:** Outside view of building which houses majority of the water treatment system.

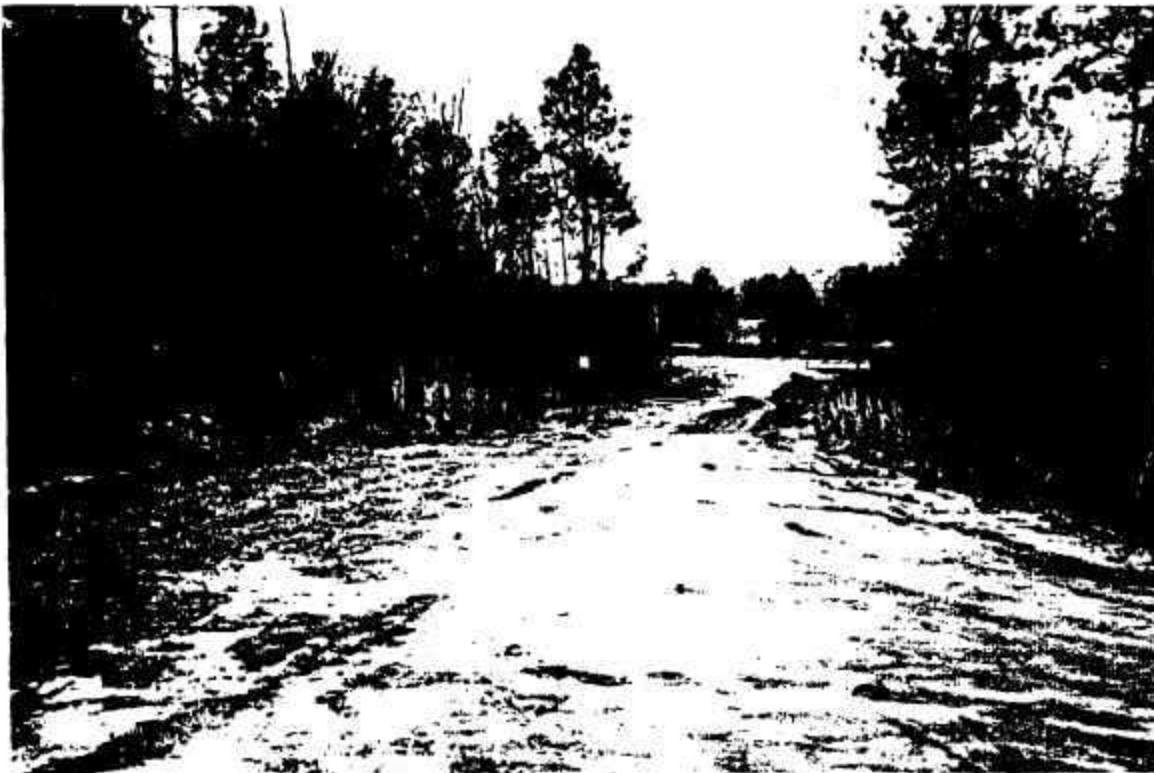
**Photograph No. 8**

**Description:** Access road following the alignment of withdrawal wells WW-1 through WW-4 along the south edge of the contaminant plume.
